**DEPARTMENT OF TRANSPORTATION****DIVISION OF ENGINEERING SERVICES**

Office of Structural Materials

Contract #: 04-0120F4Cty: SF/Ala Rte: 80 PM: 13.2/13.9File #: 69.28**WELDING INSPECTION REPORT****Resident Engineer:**Siegenthaler, Peter**Address:** 333 Burma Road**City:** Oakland, CA 94607**Report No:** WIR-023215**Date Inspected:** 25-Apr-2011**Project Name:** SAS Superstructure**OSM Arrival Time:** 1900**Prime Contractor:** American Bridge/Fluor Enterprises, a JV**OSM Departure Time:** 700**Contractor:** Zhenhua Port Machinery Company, Ltd (ZPMC), Changxing Island **Location:** Shanghai, China**CWI Name:** See below**CWI Present:** Yes No**Inspected CWI report:** Yes No N/A**Rod Oven in Use:** Yes No N/A**Electrode to specification:** Yes No N/A**Weld Procedures Followed:** Yes No N/A**Qualified Welders:** Yes No N/A**Verified Joint Fit-up:** Yes No N/A**Approved Drawings:** Yes No N/A**Approved WPS:** Yes No N/A**Delayed / Cancelled:** Yes No N/A**Bridge No:** 34-0006**Component:** OBG Components**Summary of Items Observed:**

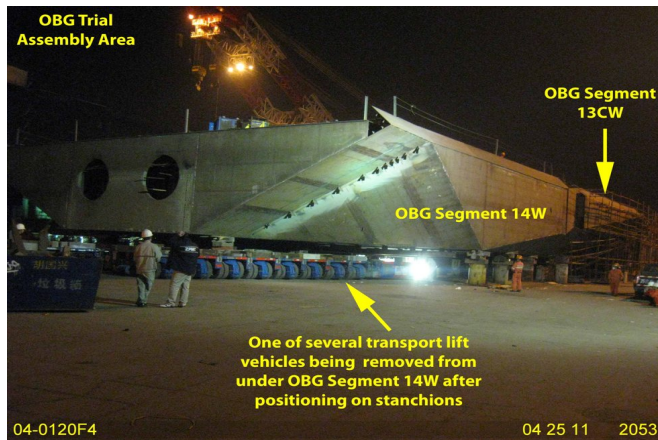
PCMK OBG 14W was moved to the OBG Trial Assembly Area and positioned to match up to PCMK OBG 13CW on this date. See photo below of transport lift vehicles being removed from under PCMK OBG 14W after positioning the segment on stanchions.

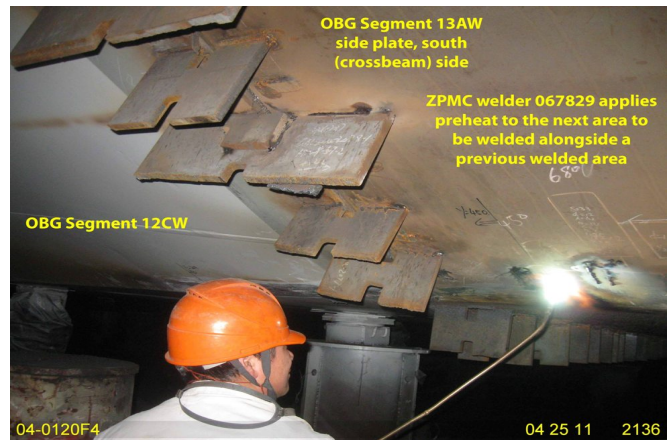
SMAW repair welding of base metal where temporary welds had been removed located on PCMK OBG 13AW near 12CW transverse joint, side plate, south (crossbeam) side. Welder was identified as 067829. QC was

identified as ABF CWI Ji Cai Fang (QC2). Assisting QC2 at this location and appearing to be monitoring the welding operation and recording data was ZPMC QC Wang Zhu (QCA2), who was not a CWI. Weld variables recorded by QCA2 appeared to comply with WPS-345-SMAW-4G(4F)-FCM-repair-1 as displayed on ZPMC Weld Repair Report B-CWR2861 as presented to this QA Inspector and verbally identified by QCA2. See photo below of ZPMC welder 067829 preheating the base metal prior to performing additional repair welds.
